Straight River (Hubbard County, MN) Nutrient Study

Kevin Stroom, MPCA
February, 2019 - **DRAFT**

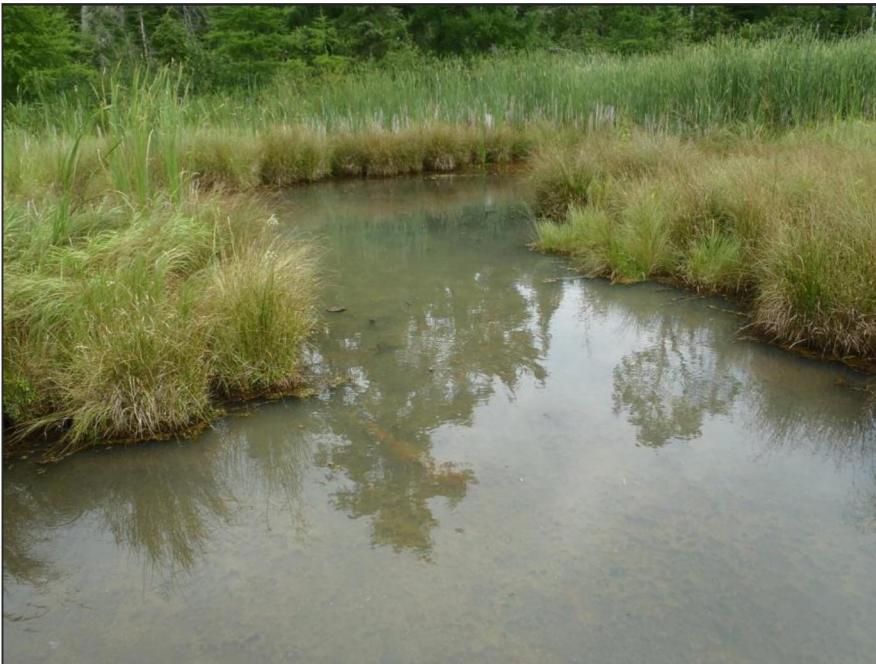
Photo 1. A large spring-water channel that enters the Straight River downstream of CR-123.

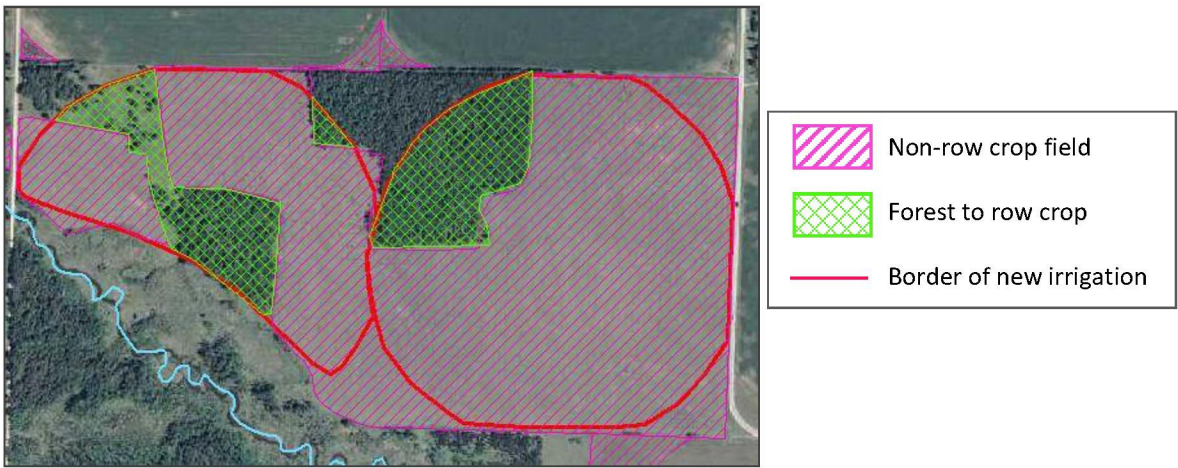
Figure 3. Example of a land cover conversion to irrigated agriculture that straddles the Shell River - Straight River subwatershed boundary. Note that forest area was also lost in this conversion to maximize irrigated field area, in addition to the perennial grassland.

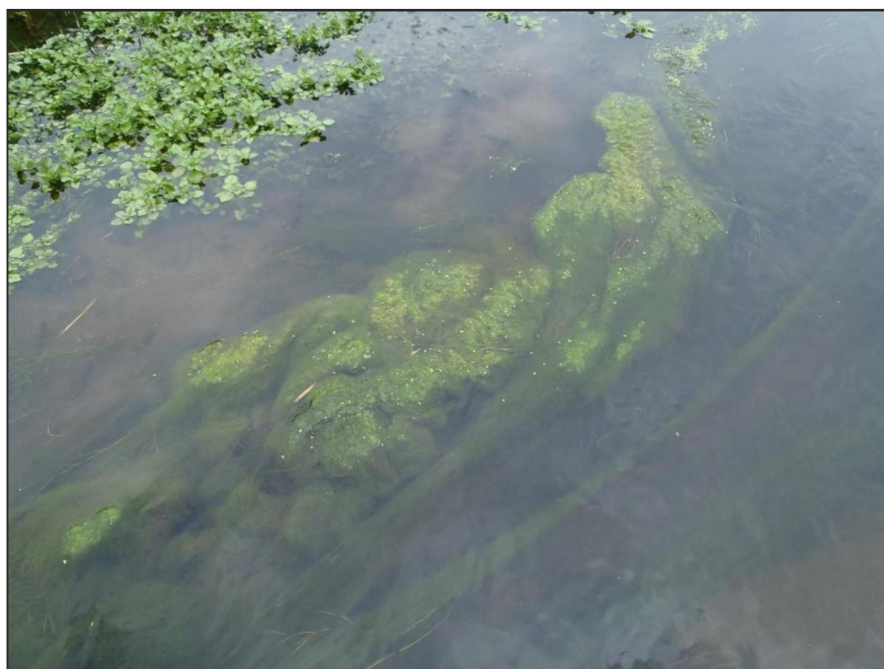
Photo 2. A large mat of filamentous algae downstream of CR-123.

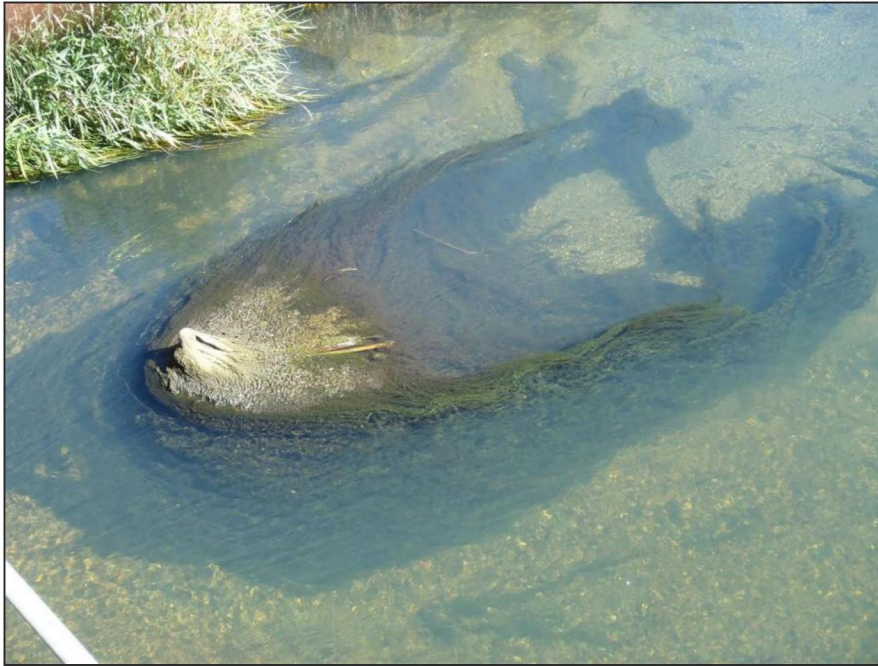
Photo 3. Algal growth on a vertical pipe, part of stream gaging equipment at Becker Line Road, Sept. 14, 2016.

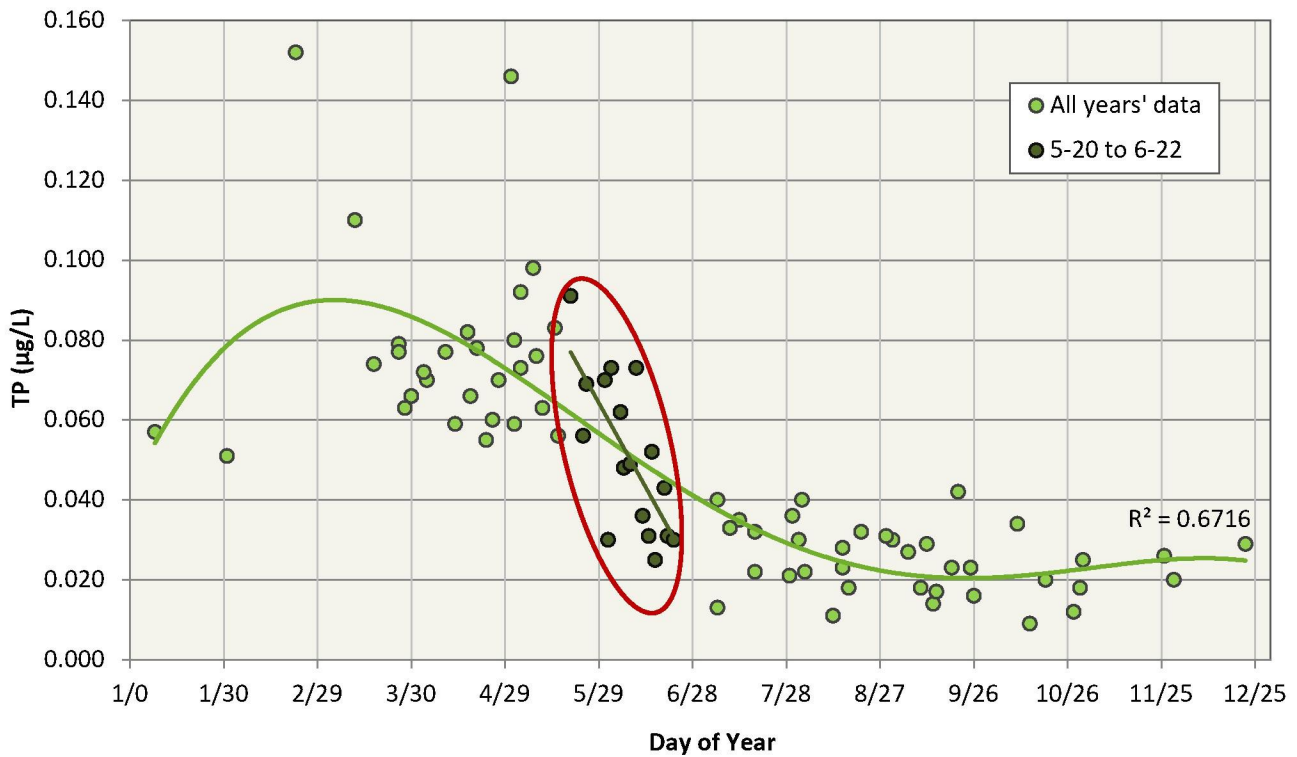
Figure 15. There is a rapid decline in TP concentration between May 20 to June 22 (the data points in the circled area). Data are from State Hwy 71 (S002-960), 2004-2010, 2015-2016. The line within the circle is a linear regression line of these data points.

There is a period of rapid decline in the TP concentrations that the data show occurring between approximately May 20 - June 22 (Figure 15). This coincides with the period of new growth of algae as water temperatures rise and days lengthen. Following this period, the remainder of the summer has relatively stable levels of TP.

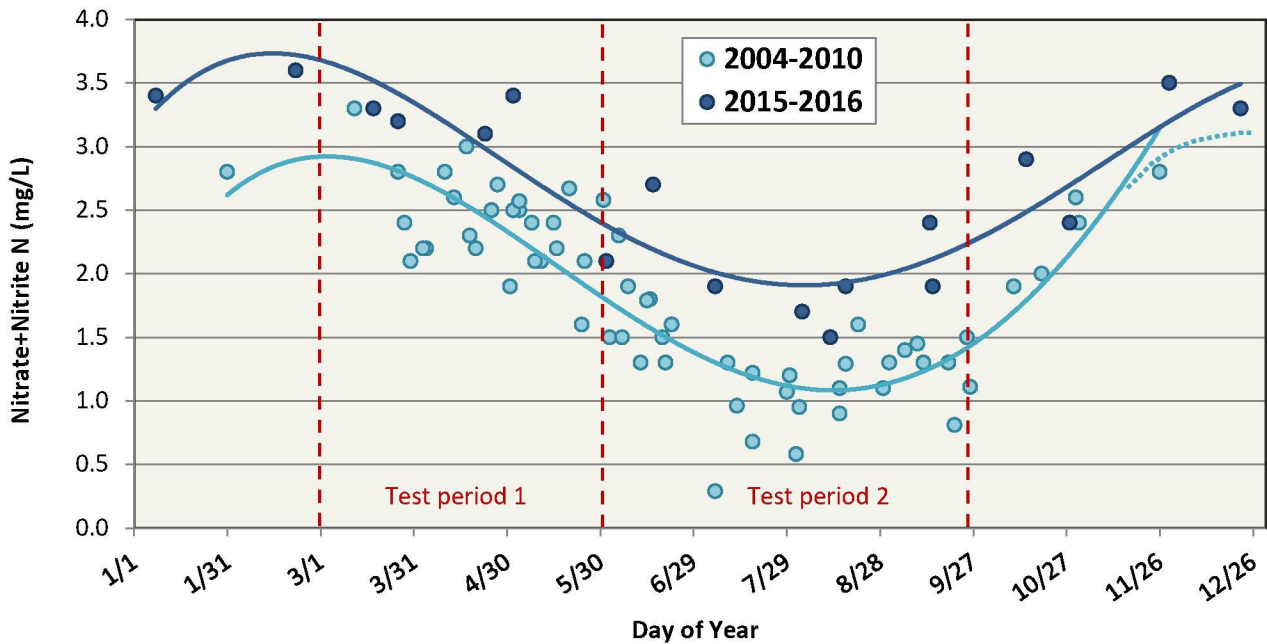
Figure 17. Significance testing of the two datasets, broken into two time periods with many data points, spring (1) and summer (2).

The increase in nitrate between the two sample datasets was tested statistically, and difference was found to be significant (Figure 17). Because of the sinuous pattern of the data, the year was broken into two time periods for significance-testing, spring and summer. Both seasons had highly statistically significant differences between data sets, with p-values of 0.003 and < 0.000 respectively (Mann-Whitney U Test).
