AFOEHL REPORT 89-129EQ0063LEA

Biological Analysis of Three Ponds at Peterson AFB,
Colorado Springs CO

November 1989

AF Occupational and Environmental Health Laboratory (AFSC)
Human Systems Division
Brooks Air Force Base, Texas 78235-5501

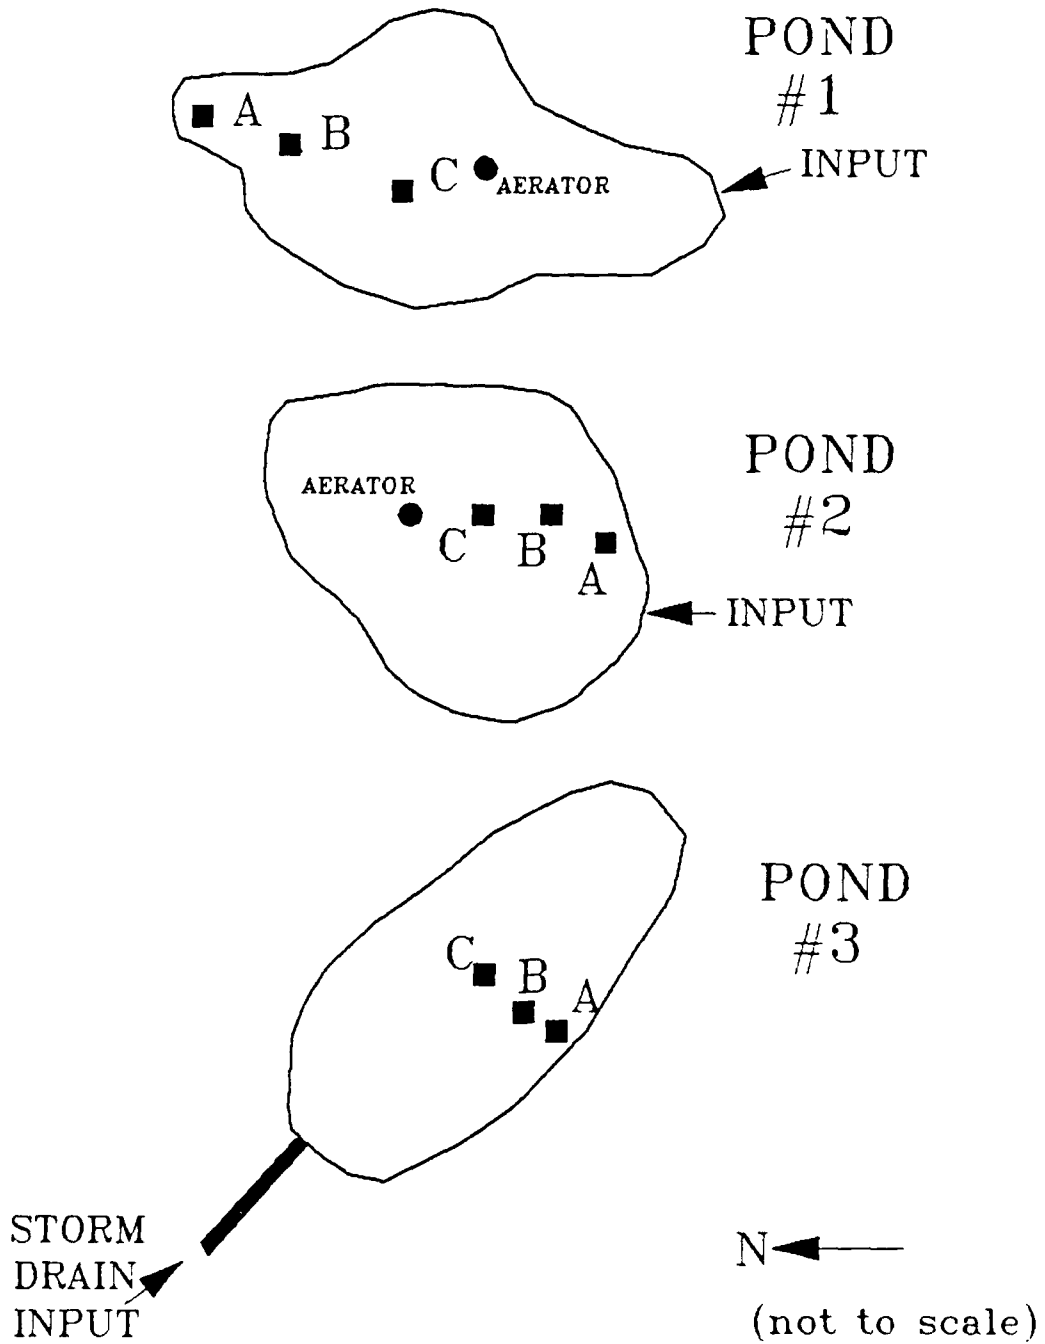
FIG. 2 SAMPLING SITES

All sampling was conducted during the period 6-8 June 1989. Three sampling sites were established in each pond: station C was near the deepest point of each pond; station B was located where the water depth equaled the depth of the photic zone; station A was approximately 1 meter from the shoreline. The biological health of all three ponds was evaluated at the population level (Warren, 1971) by qualitatively and quantitatively sampling the water column and the benthos (bottom sediment) for invertebrates, vertebrates and plants. The water column was sampled for plants and animals with plankton nets, seines and water bottles. Benthic samples were taken along transects with grab samplers for macrobenthos and cores for meiobenthos and the infauna preserved in the field. Since there is a gradient to the impact, with pond 2 being slightly impacted and pond 1 apparently not having been impacted at all, pond 1 was used as a control for comparing species

Replicate phytoplankton samples were collected at stations C and B in all ponds by filling a 2-liter bottle with water, 0.5 meters under the water surface. Figure 2 locates the sampling sites. The samples were immediately preserved with Lugol's fixative (Wetzel and Likens, 1979). Three 1 ml subsamples were counted from each sample using a Sedgwick-Rafter counting cell under 100X magnification. The phytoplankton were identified to the genus level and the results summarized in Table 2. The diversity of species at each station in each pond was calculated by using the Shannon-Wiener species diversity index (H') (Shannon and Wiener, 1963).
